# Portage Creek Sediment Remediation Project Kalamazoo, Michigan

Post-Sediment Removal Structure Feature Assessment  
Removal Areas SA5-Axtell, SA5-D and SA5-C

F&V Project Number: 809930  
October, 2012

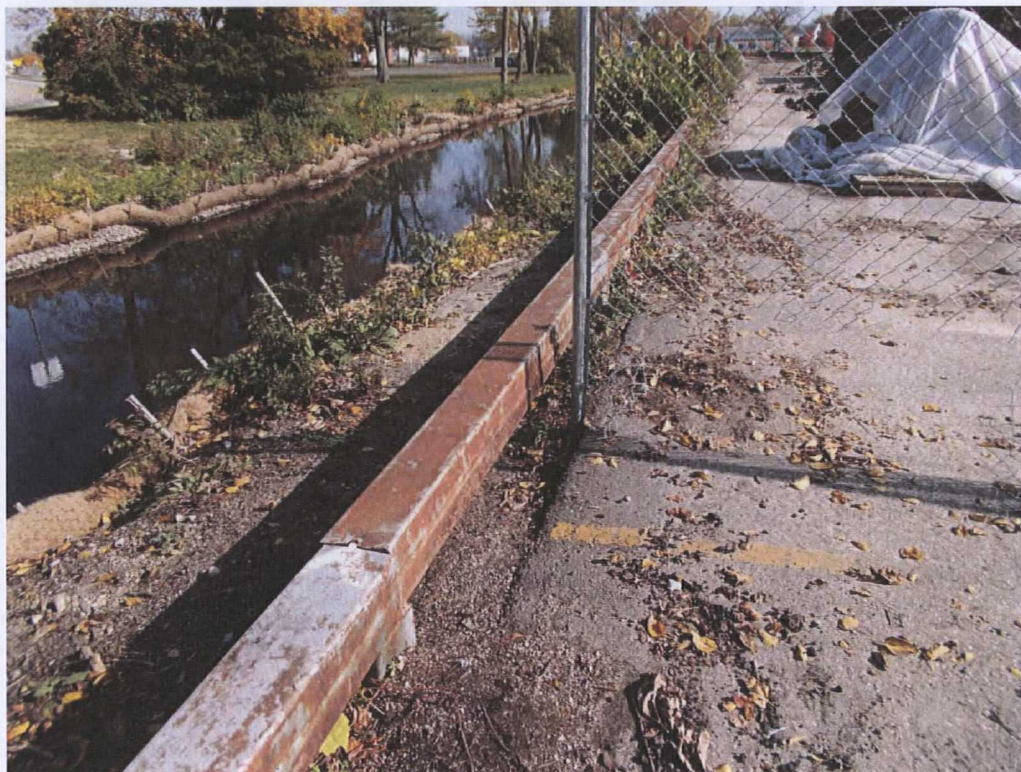
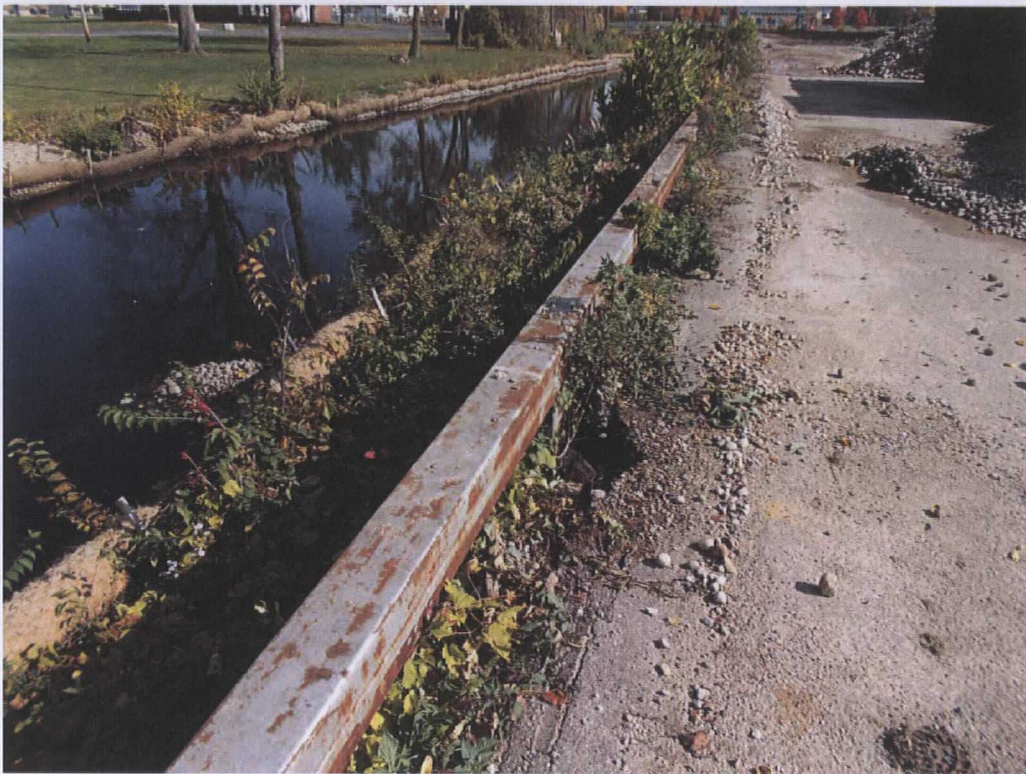
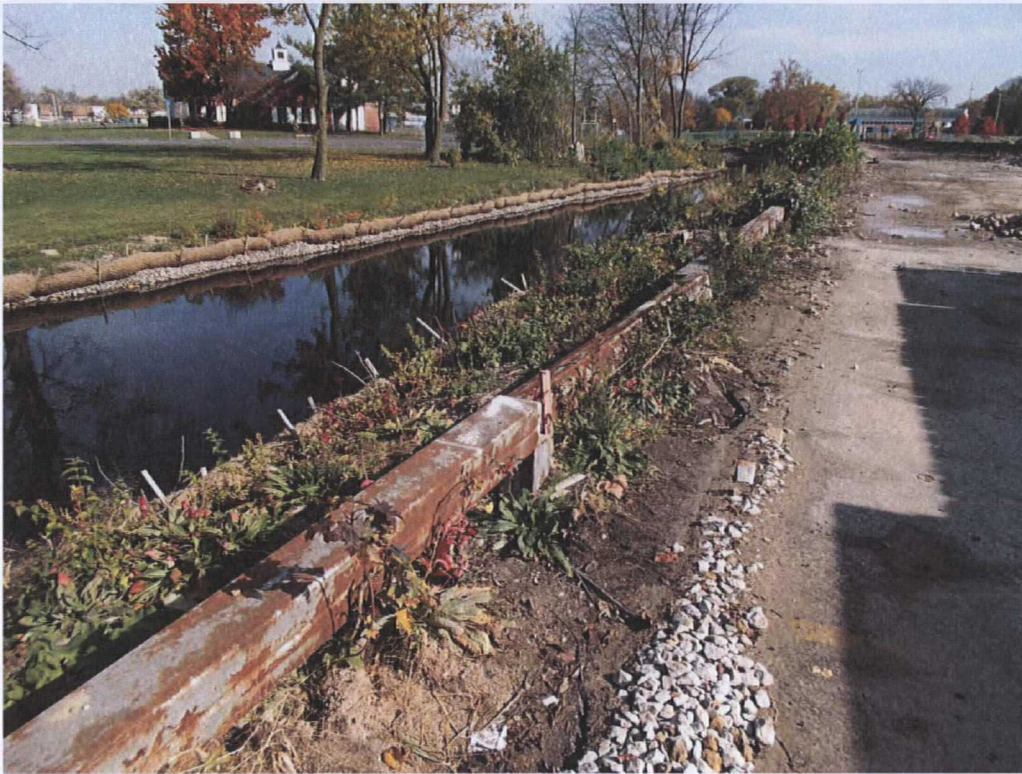
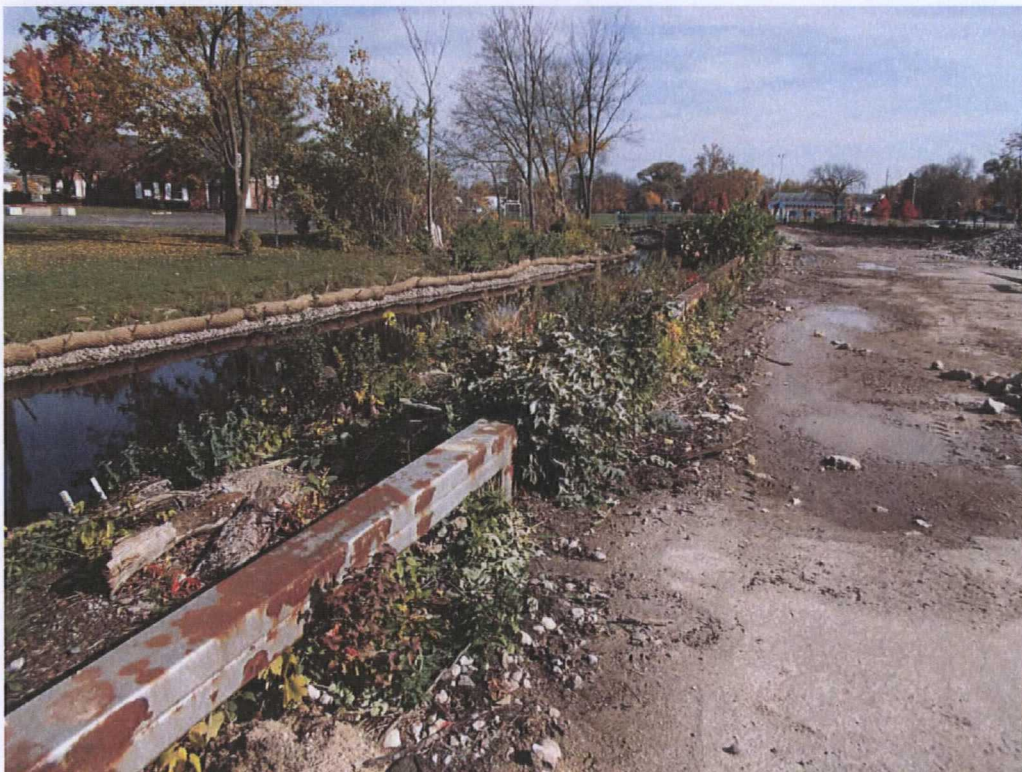
- There are still several failed section of railing.
- The structure does not appear to have been impacted during sediment removal.

View of the rail looking east

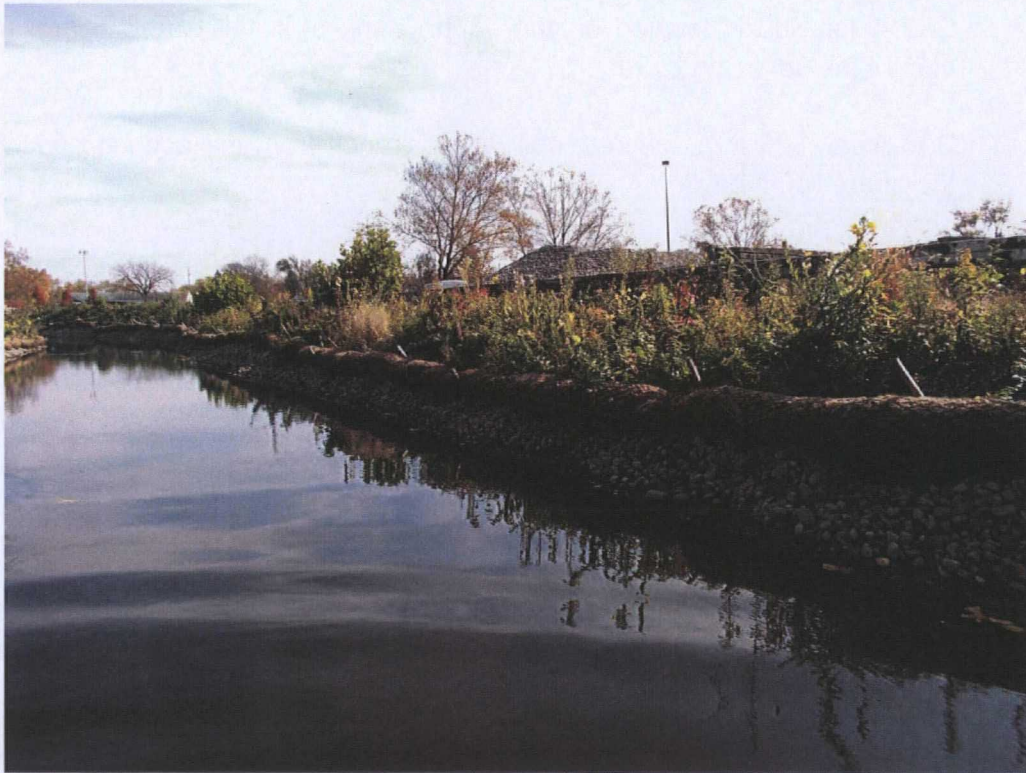
- The lower section of the spillway was removed in conjunction with sediment removal.
- The upper section does not appear to have been impacted during sediment removal.

View of bank restoration at the structure

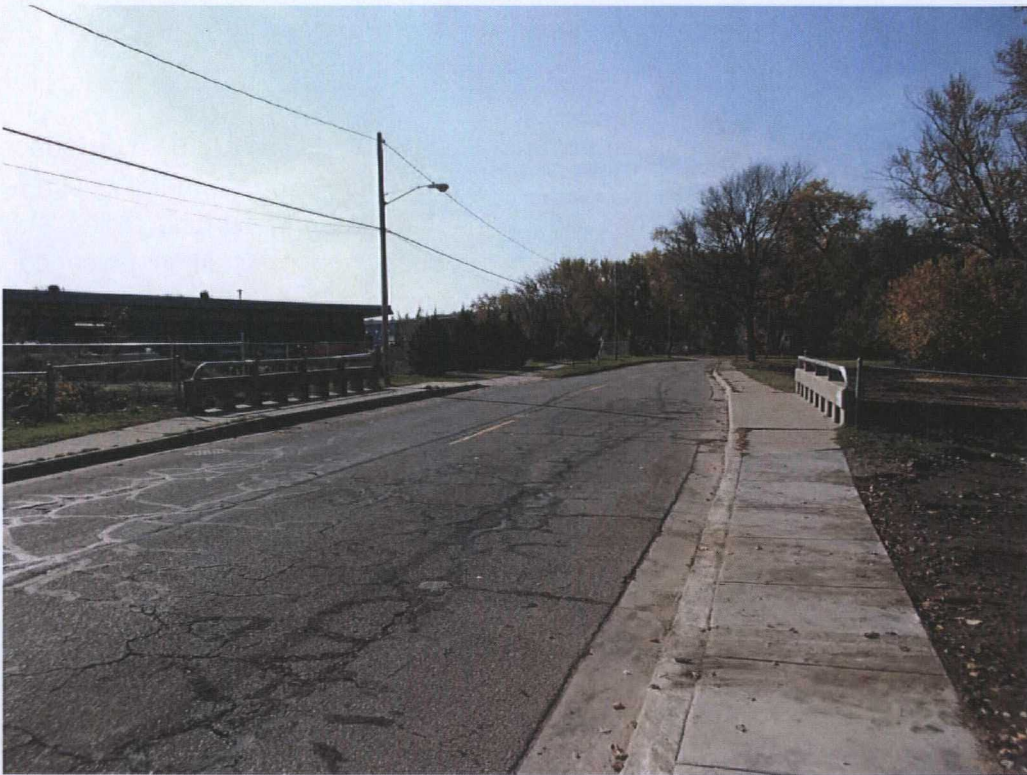
- The curb head was removed in the northeast quadrant to facilitate access. It and the adjacent sidewalk appear to have been marked for replacement.
- Restoration is required in the northwest and northeast quadrants.
- The fence along the northwest block wall should be replaced.
- The structure itself does not appear to have been impacted during sediment removal.

View of the structure from the northeast approach area

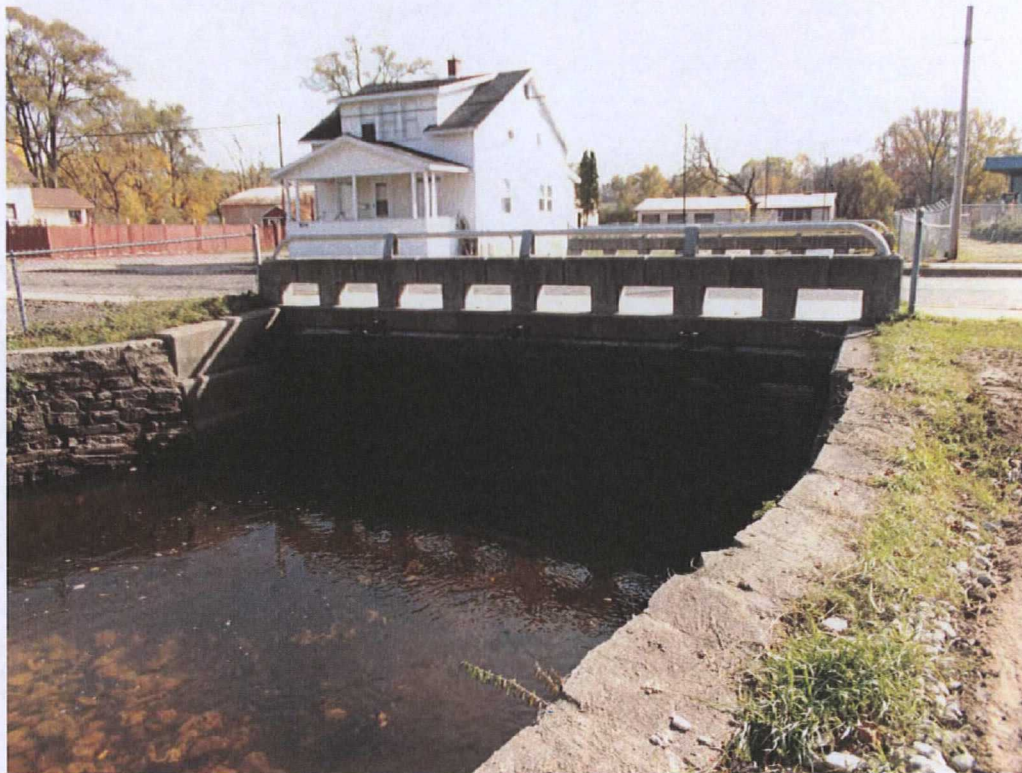
Elevation view of structure from northwest bank

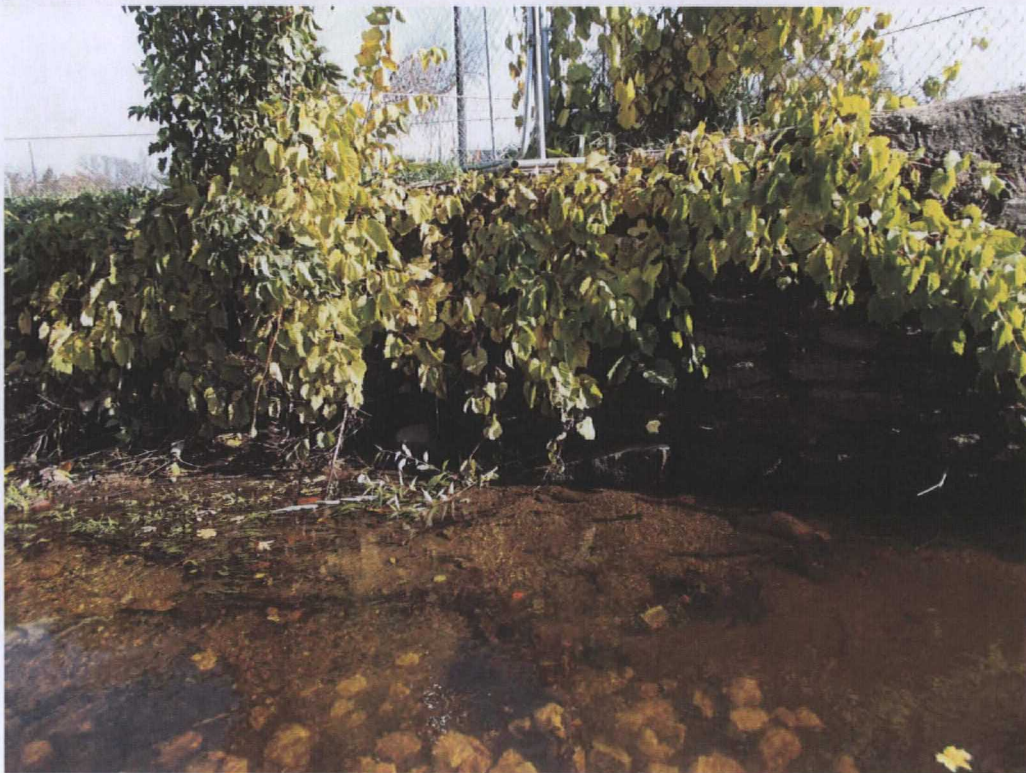
View of northeast block wall from the channel

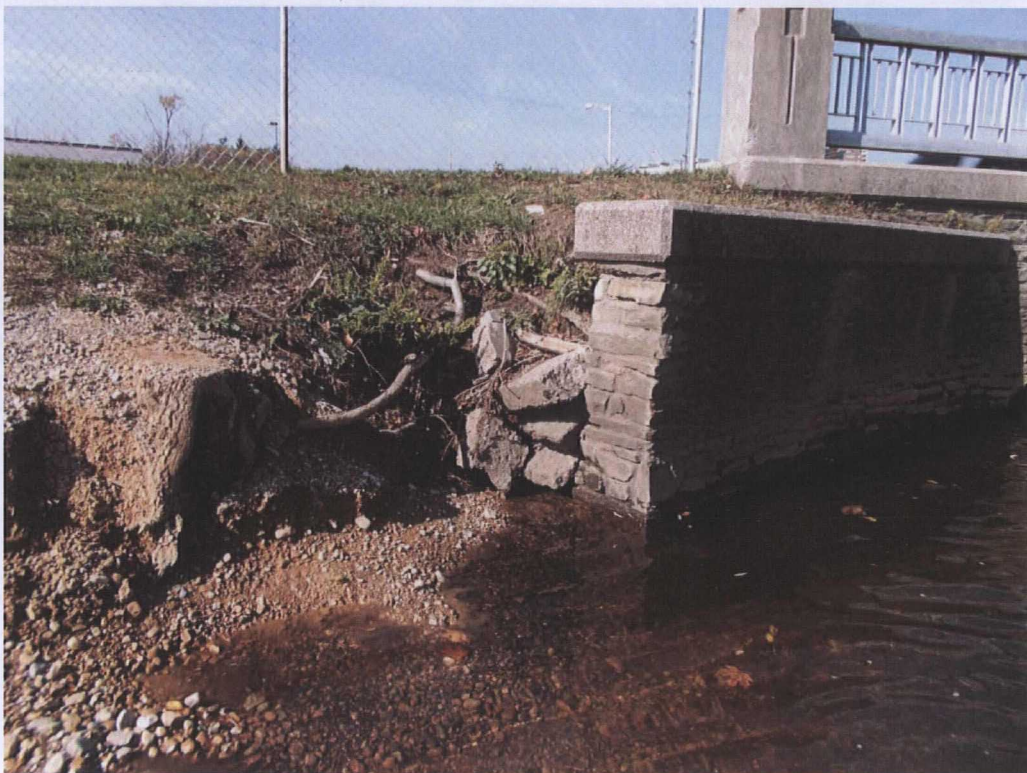
View of the southwest wingwall

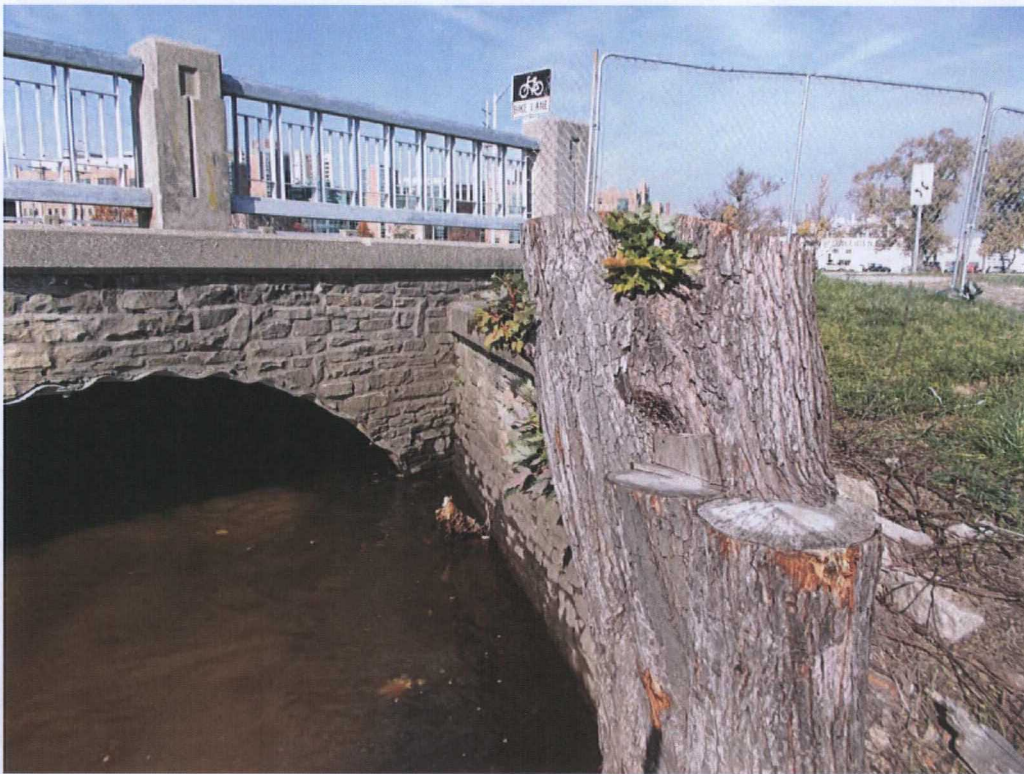
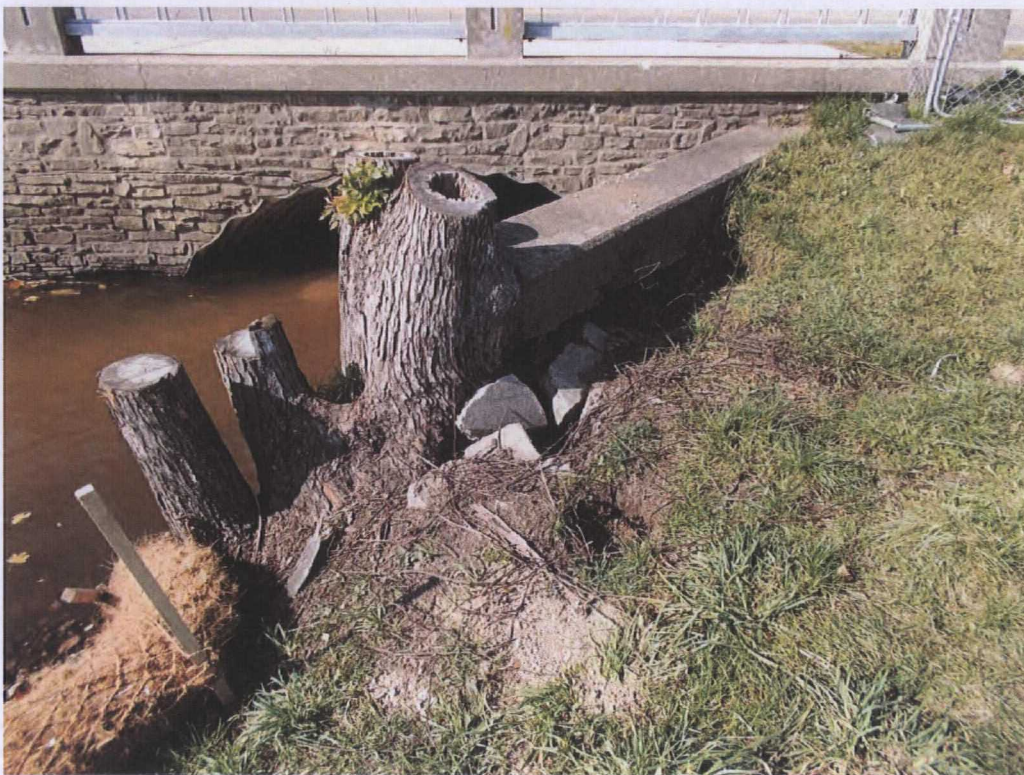
View of the southeast wingwall

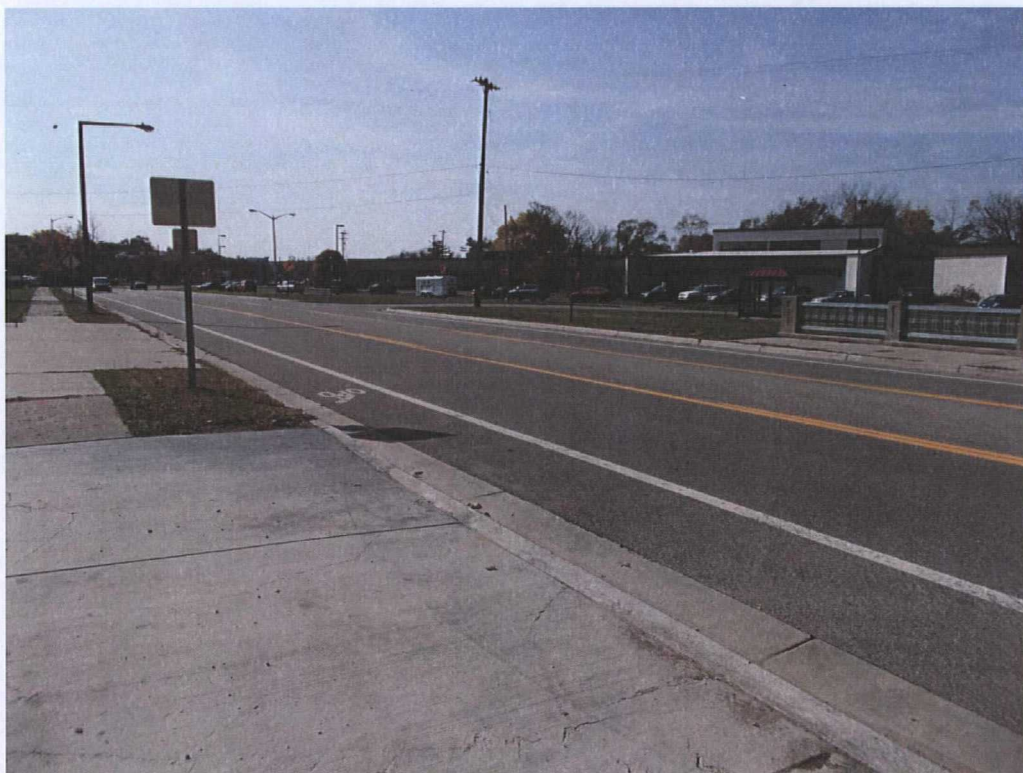
View of the structure from the southeast approach area

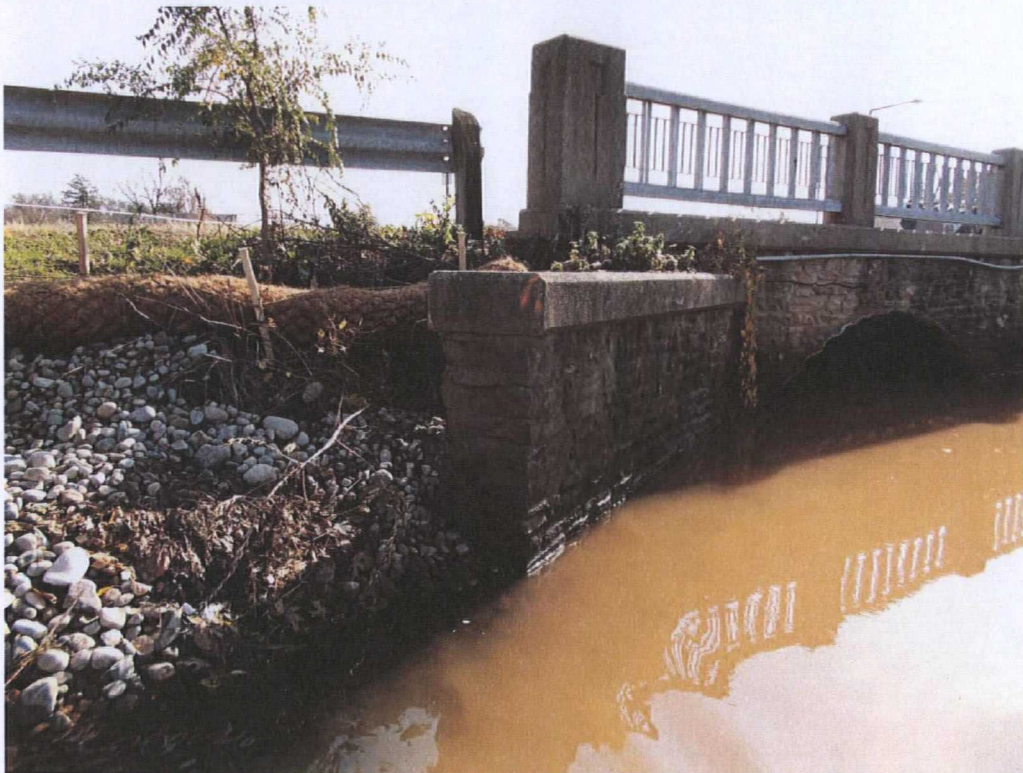
View of the northeast wingwall

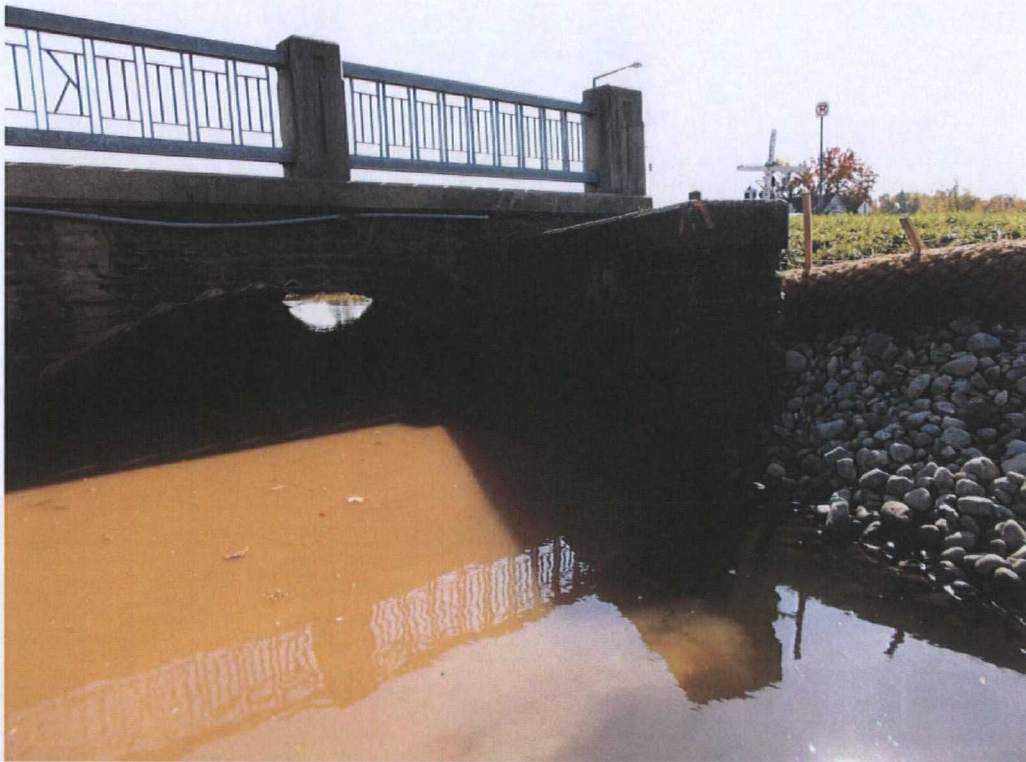
View of the northwest wingwall

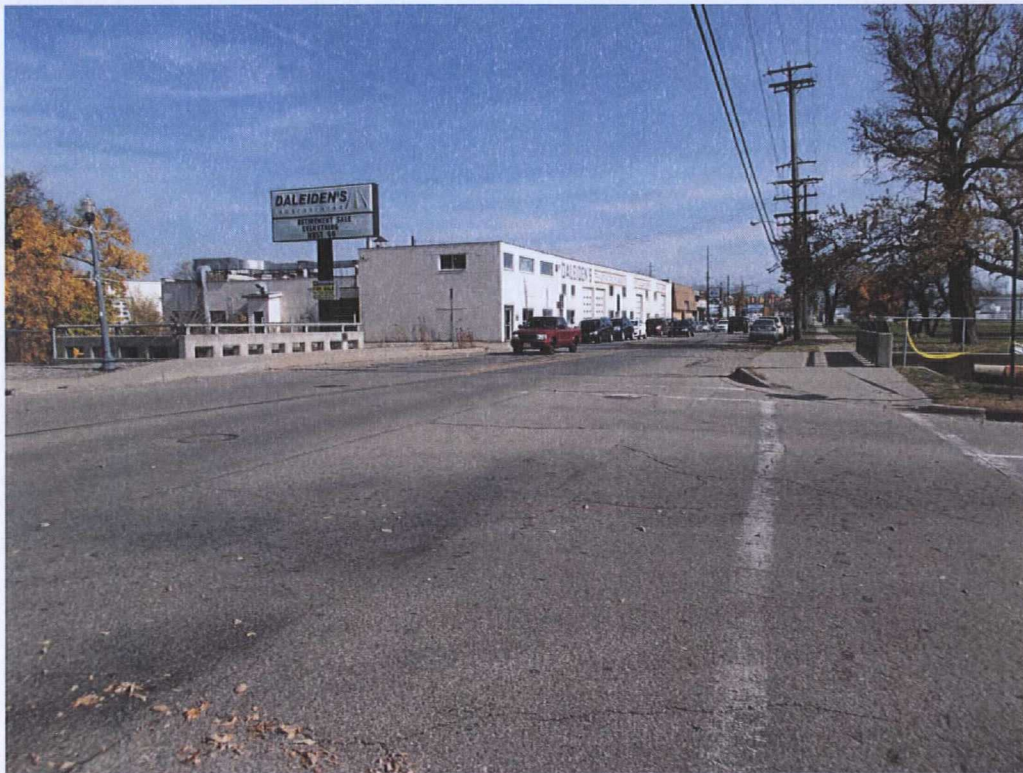
View of structure from the southwest approach area

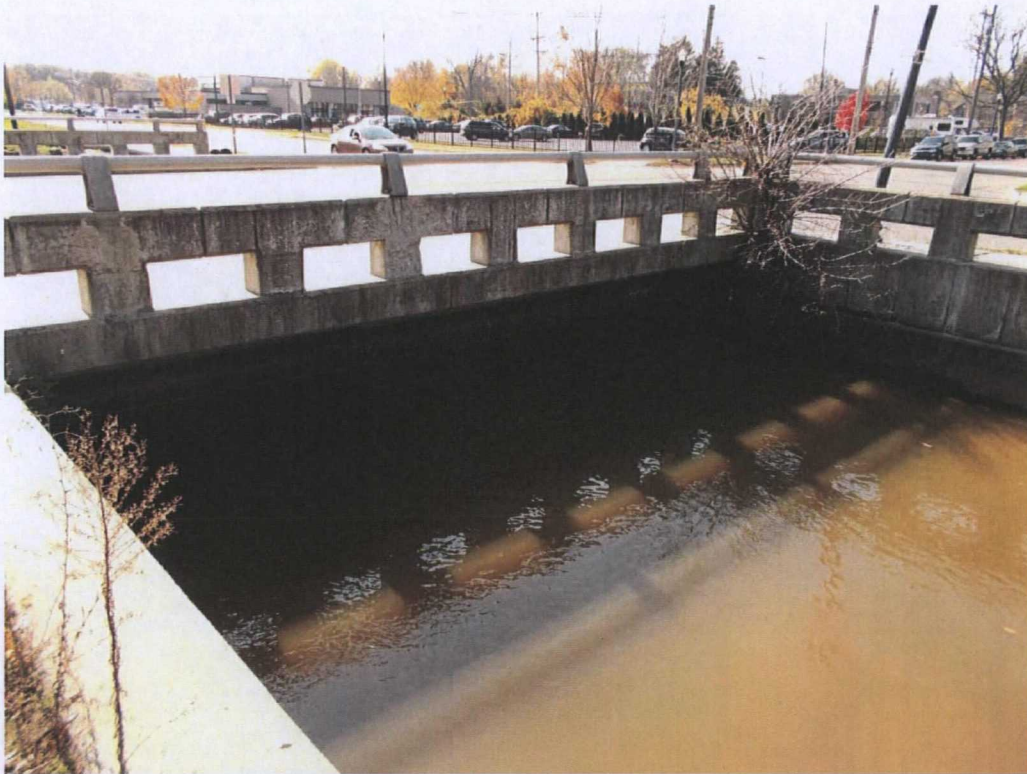
North elevation view of the structure

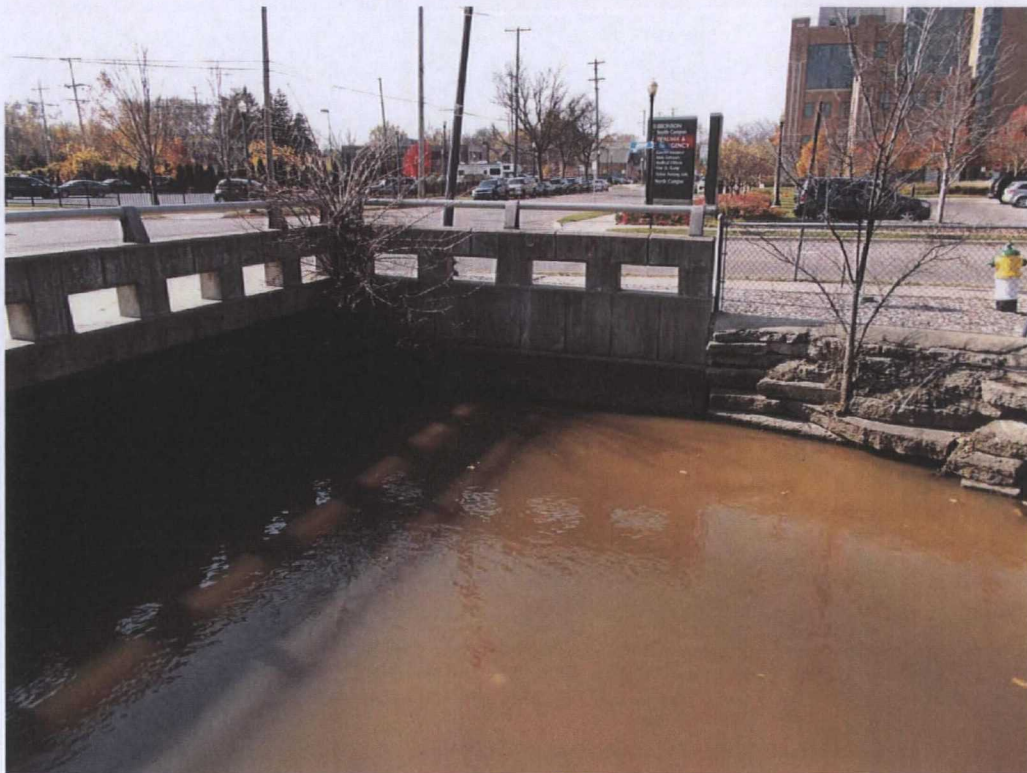
View of the northwest wingwall

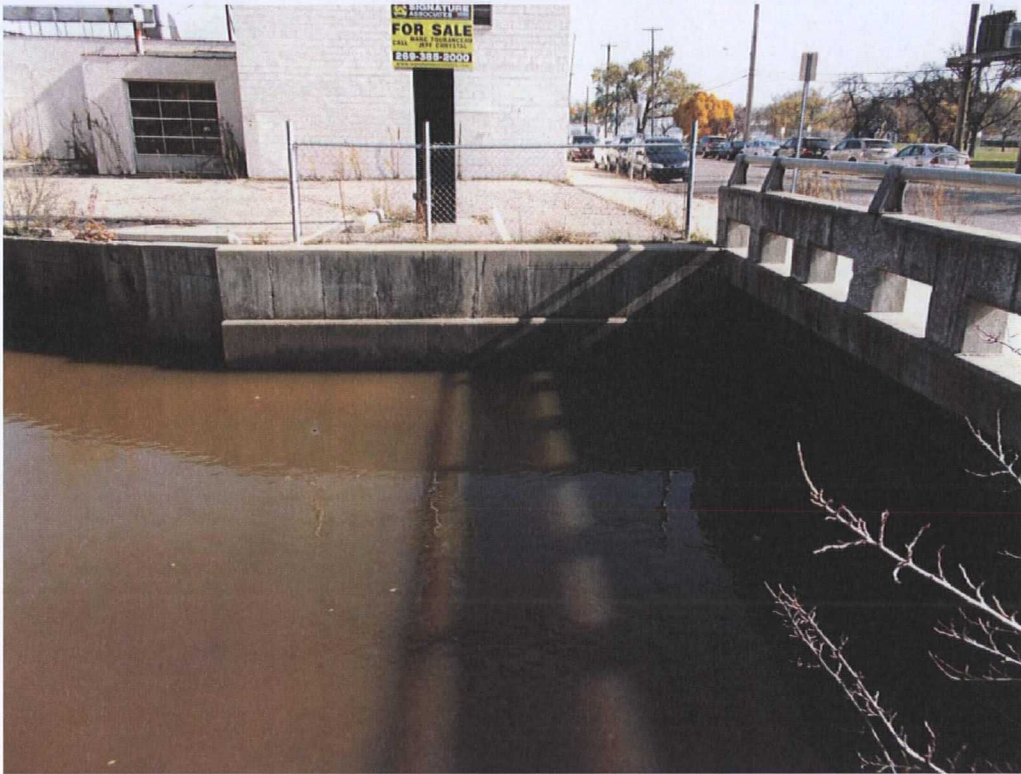
View of the northeast wingwall
